**Flood Control Project Maintenance
Levee Inspections**

Fall 2018 Levee Maintenance Deficiency Summary Report

Reclamation District No. 2107 Mossdale Island

Levee Inspection Report By Mile - Fall 2018

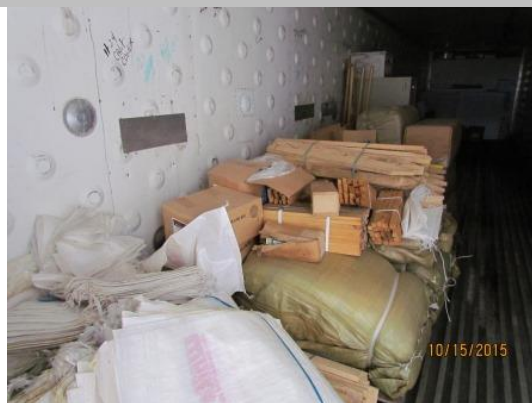
Photo 1 of 1 : FA_2018_RD2107_329_7_20180911_00001.jpg

LM Start		Rating **	A	Issue No.	7
LM End		Issue Type +	Ma	Location *	
Category	Earthen Levee		GPS Latitude/Longitude		
			Start	End	
Item	Emergency Supplies & Equipment				
DWR ID	DWR_RD2107_01_s_2013_7				
Comment Code					
Inspector Comment					
Flood fighting supplies are available on-site.

View of the flood fight emergency supplies.

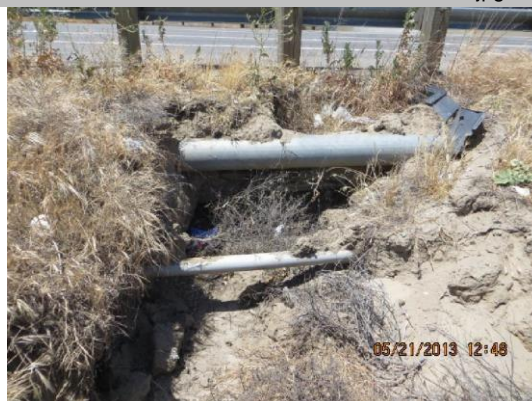
Photo 1 of 1 : UCIP_FA_2018_16187_27294.jpg

LM Start	0.23	Rating **	M	Issue No.	21
LM End	0.23	Issue Type +	En	Location *	
Category	Supplemental			GPS Latitude/Longitude	
				Start	End
Item	DWR UCIP Field Study			37.784586 °	37.784586 °
				-121.306837 °	-121.306837 °
DWR ID	23107				
Comment Code					
Inspector Comment					
FS_ID:16187 DS_ID:23107 EP_NO: N/A Repair Type: Non-Urgent Crossing Status: Found UCIP Comments: No permit identified. Erosion exposed pipes on LS. FIELD_STRUCT_DESC: 3-inch polyvinyl chloride (PVC) conduit of an unknown purpose, 1 foot below the road surface, within roadway fill over the levee crown. FS Date: 5/22/2013

Pipes visible on LS next to roadway.

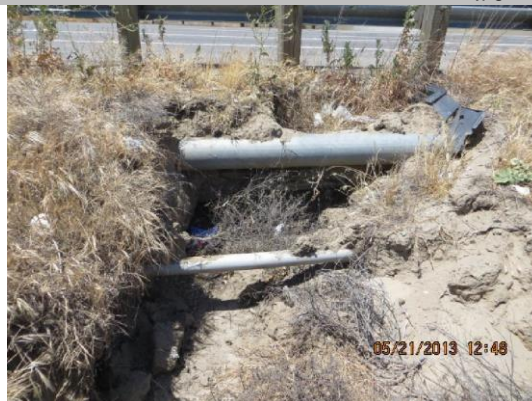
Photo 1 of 1 : UCIP_FA_2018_15175_24922.jpg

LM Start	0.23	Rating **	M	Issue No.	22
LM End	0.23	Issue Type +	En	Location *	
Category	Supplemental			GPS Latitude/Longitude	
				Start	End
Item	DWR UCIP Field Study			37.784586 °	37.784586 °
				-121.306837 °	-121.306837 °
DWR ID	23108				
Comment Code					
Inspector Comment					
FS_ID:15175 DS_ID:23108 EP_NO: N/A Repair Type: Non-Urgent Crossing Status: Found UCIP Comments: No permit identified. Erosion exposed pipes on LS. FIELD_STRUCT_DESC: 8-inch steel conduit of an unknown purpose, 1 foot below the road surface, within roadway fill over the levee crown. Visible on the upstream side of the bridge. FS Date: 5/22/2013

Pipes visible on LS next to roadway.

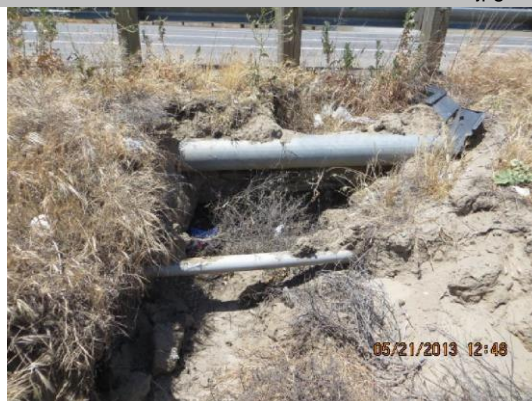
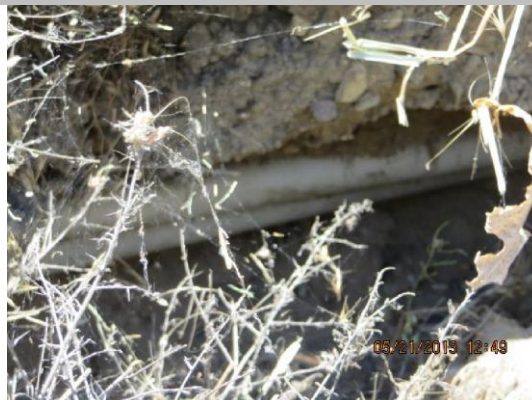
LM Start	0.23	Rating **	M	Issue No.	23	
LM End	0.23	Issue Type +	En	Location *		
Category	Supplemental			GPS Latitude/Longitude		
				Start	End	
Item	DWR UCIP Field Study			37.784586 °	37.784586 °	
				-121.306837 °	-121.306837 °	
DWR ID	23109					
Comment Code						
Inspector Comment						
FS_ID:15173						
DS_ID:23109						
EP_NO: N/A						
Repair Type: Non-Urgent						
Crossing Status: Found						
UCIP Comments: No permit identified for this crossing. Erosion exposed pipes on LS.						
FIELD_STRUCT_DESC: 1.5-inch polyvinyl chloride (PVC) conduit of an unknown purpose, 1 foot below the road surface, within roadway fill over the levee crown.						
FS Date: 5/22/2013

Pipes visible on LS next to roadway.

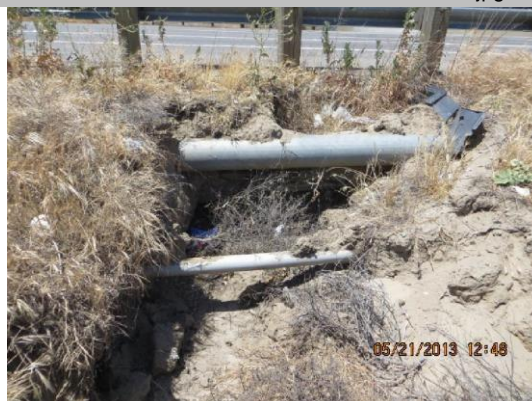
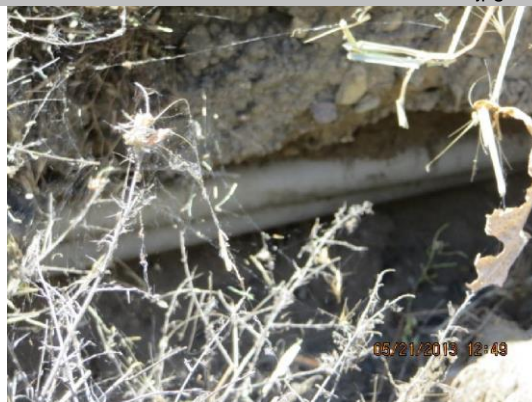
LM Start	0.23	Rating **	M	Issue No.	24
LM End	0.23	Issue Type +	En	Location *	
Category	Supplemental			GPS Latitude/Longitude	
				Start	End
Item	DWR UCIP Field Study			37.784586 °	37.784586 °
				-121.306837 °	-121.306837 °
DWR ID	23110				
Comment Code					
Inspector Comment					
FS_ID:15174 DS_ID:23110 EP_NO: N/A Repair Type: Non-Urgent Crossing Status: Found UCIP Comments: No permit identified for this crossing. FIELD_STRUCT_DESC: 1.5-inch polyvinyl chloride (PVC) conduit of an unknown purpose, 1 foot below the road surface, within roadway fill over the levee crown. FS Date: 5/22/2013

Pipes visible on LS next to roadway.

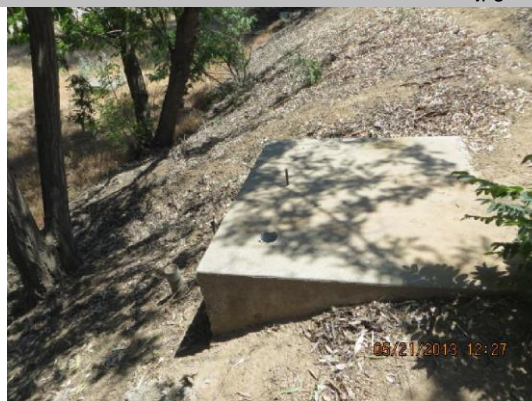
Photo 1 of 1 : UCIP_FA_2018_16188_27296.jpg

LM Start	0.27	Rating **	M	Issue No.	25
LM End	0.27	Issue Type +	En	Location *	
Category	Supplemental			GPS Latitude/Longitude	
				Start	End
Item	DWR UCIP Field Study			37.784194 °	37.784194 °
				-121.306353 °	-121.306353 °
DWR ID	19055				
Comment Code					
Inspector Comment					
FS_ID:16188 DS_ID:19055 EP_NO: 12101B Repair Type: Non-Urgent Crossing Status: Found UCIP Comments: Appears abandoned and should be done so properly. FIELD_STRUCT_DESC: 4" electrical conduit through the levee 2.5 feet below the crown. Distribution panel on a 5-foot by 6-foot concrete pad on the WS shoulder (Permit No 12101B, 1979). FS Date: 5/21/2013

5X5 concrete pad with exposed electrical conduit on WS shoulder.

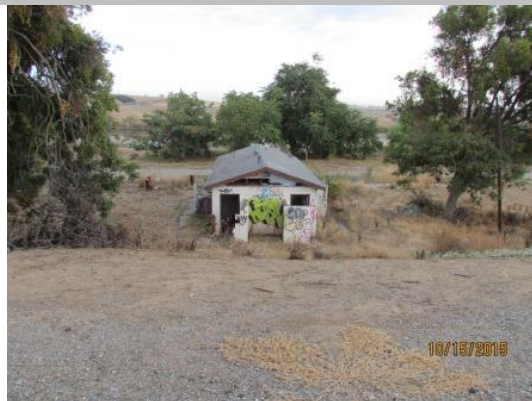
Photo 1 of 1 : FA_2018_RD2107_329_20_20180911_00005.jpg

LM Start	0.32	Rating **	M	Issue No.	20
LM End	0.32	Issue Type +	En	Location *	WS
Category	Earthen Levee			GPS Latitude/Longitude	
				Start	End
Item	Encroachments			37.783649 °	37.783649 °
				-121.305710 °	-121.305710 °
DWR ID	DWR_RD2107_01_f_2015_20				
Comment Code					
BU : Building					
Inspector Comment					
Building in the floodway may impede flood flows.

View of the building in the floodway.

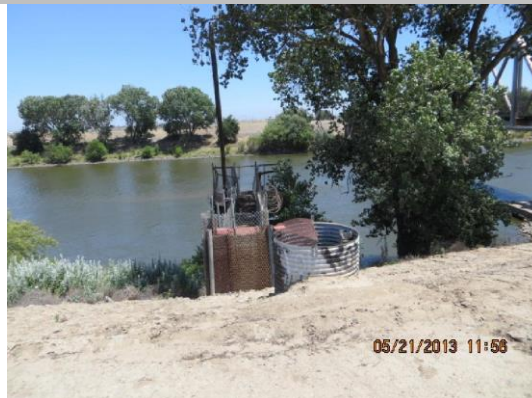
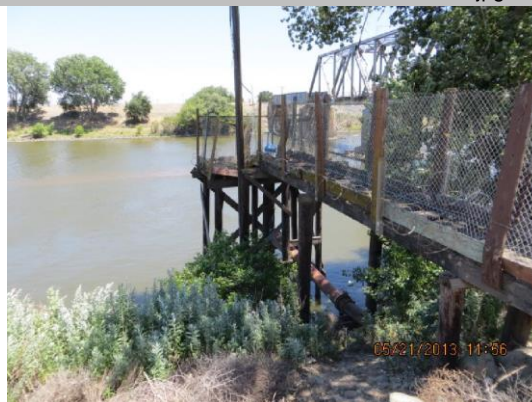
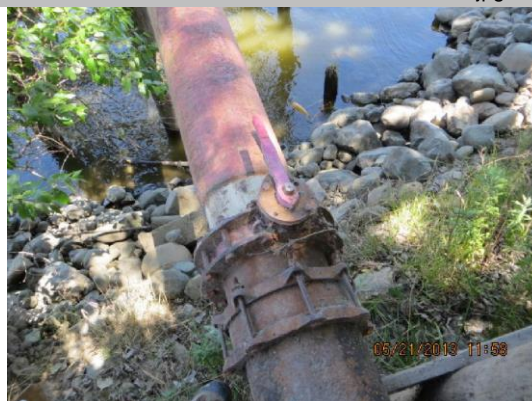
Comment Code					
Inspector Comment					
FS_ID:13684 DS_ID:19036 EP_NO: N/A Repair Type: Non-Urgent Crossing Status: Found UCIP Comments: Wooden walkway to pump on platform is in disrepair and may be a hazard. FIELD_STRUCT_DESC: 1 of 2: 14-inch irrigation pipe of an unknown material through the levee, 17 feet below the crown. Pump on pile structure in the stream. Walkway to pump. Slide gate in a 48-inch corrugated metal pipe (CMP) riser on the waterside (WS) shoulder. 36-inch concrete standpipe at the landside (LS) toe. Service pole and circuit panel on the LS toe. [Additional Reference(s): DWR Levee Log, 2005. USACE San Joaquin O&M Manual 9, April 1964, (HLM 0.68), 12-inch pipe listed]. FS Date: 5/21/2013

Pier and 48-inch CMP riser on WS shoulder

Walkway to pump on pier at WS.

Butterfly valve on WS toe.

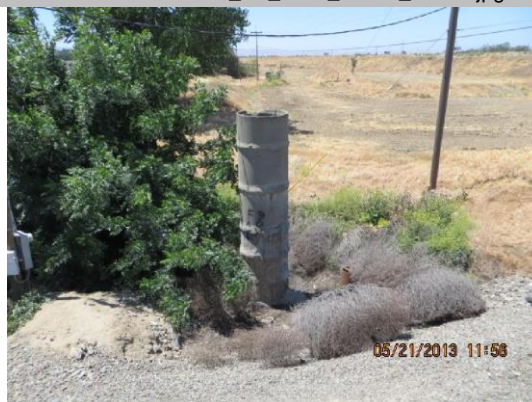
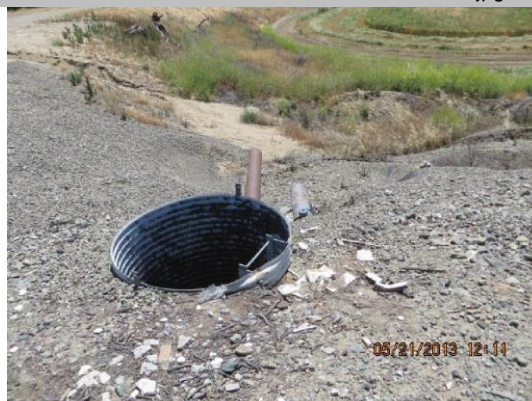
Comment Code					
Inspector Comment					
FS_ID:13883					
DS_ID:19039					
EP_NO: N/A					
Repair Type: Non-Urgent					
Crossing Status: Found					
UCIP Comments: Slide gate missing actuator inside 55-inch CMP riser.					
FIELD_STRUCT_DESC: 14-inch irrigation pipe of an unknown material					
through the levee, 15 feet below the crown. Pipe likely runs from a 36-					
inch concrete standpipe on the landside (LS) to outlet on the waterside					
(WS) toe. Portion of the discharge line from the pump at Levee Mile

0.68. 55-inch corrugated metal pipe (CMP) riser with slide gate on the					
LS shoulder. [Additional Reference(s): DWR Levee Log, 2005. USACE					
San Joaquin O&M Manual 9, April 1964, (HLM 0.71)].					
FS Date: 5/21/2013

36-inch concrete standpipe on LS toe.

55-inch CMP riser with slide gate (no handle) on LS shoulder. 14-inch and 12-inch pipe visible on LS toe.

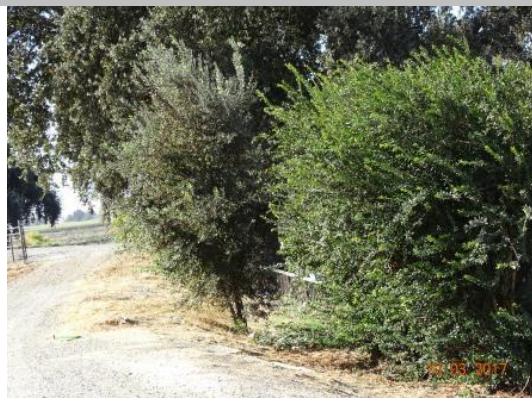
Photo 1 of 1 : FA_2018_RD2107_329_17_20180911_00004.jpg

LM Start	1.23	Rating **	M	Issue No.	17
LM End	1.23	Issue Type +	En	Location *	LS
Category	Earthen Levee			GPS Latitude/Longitude	
				Start	End
Item	Vegetation			37.774123 °	37.774123 °
				-121.307189 °	-121.307189 °
DWR ID	DWR_RD2107_01_s_2012_17				
Comment Code					
V6 : Landscaping					
Inspector Comment					
Landscaping and fence present on levee slope.

View of landscape planting on landside levee slope and a 3-ft yard fence at the levee toe.

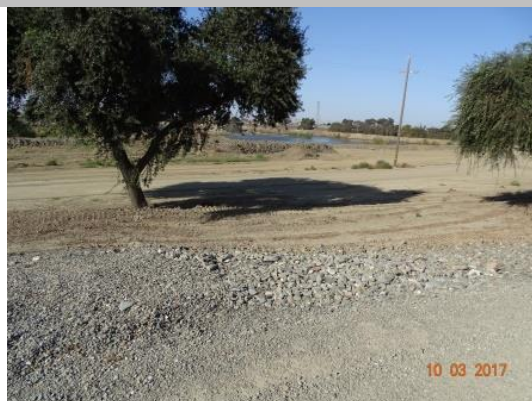
Photo 1 of 1 : FA_2018_RD2107_329_15_20180911_00003.jpg

LM Start	1.34	Rating **	A/W	Issue No.	15
LM End	1.34	Issue Type +	Ob	Location *	
Category	Supplemental			GPS Latitude/Longitude	
				Start	End
Item	2017 Storm Damage			37.772704 °	37.772704 °
				-121.306793 °	-121.306793 °
DWR ID	DWR_RD2107_01_f_2017_15				
Comment Code					
Inspector Comment					
Levee Evaluation Comments					
Description:					
Site ID No:111					
Site Designation:208-4					
Repair Type: Seepage					
Rating:					
Field Date:					
Notes: In 1997 there was heavy seepage at this location. In 2017 there was no seepage observed at this location.

View of the historic seepage site.

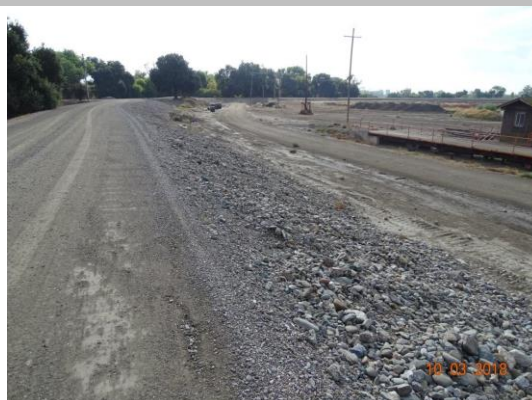
Photo 1 of 1 : FA_2018_RD2107_329_18_20181003_00024.jpg

LM Start	1.35	Rating **	A/W	Issue No.	18
LM End	1.45	Issue Type +	Ob	Location *	
Category	Supplemental			GPS Latitude/Longitude	
				Start	End
Item	2017 Storm Damage			37.772470 °	37.771910 °
				-121.306820 °	-121.304990 °
DWR ID	DWR_RD2107_01_f_2017_18				
Comment Code					
Inspector Comment					
Levee Evaluation Comments					
Description:					
Site ID No:113					
Site Designation:208-1					
Repair Type: Seepage					
Rating:					
Field Date:					
Notes: No seepage observed in 2017.

View of the newly constructed seepage berm on the landside slope. Fall 2018.

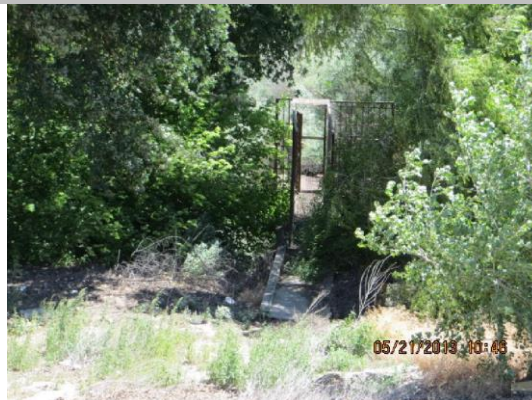
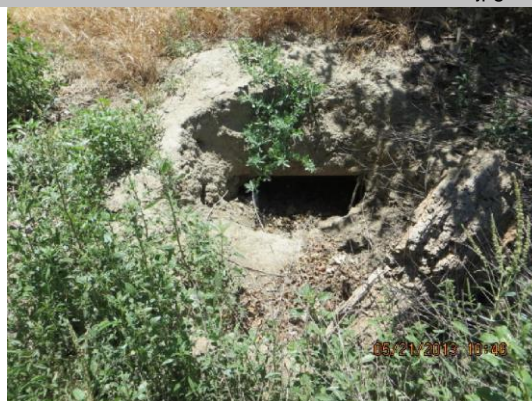
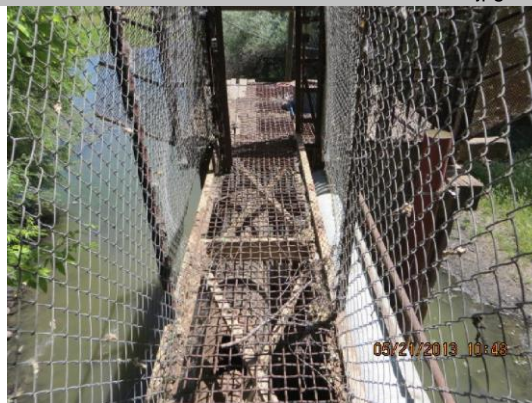
LM Start	1.47	Rating **	M	Issue No.	29	
LM End	1.47	Issue Type +	En	Location *		
Category	Supplemental			GPS Latitude/Longitude		
				Start		End
Item	DWR UCIP Field Study			37.771735 °		37.771735 °
				-121.304847 °		-121.304847 °
DWR ID	19040					
Comment Code						
Inspector Comment						
FS_ID:13650 DS_ID:19040 EP_NO: N/A Repair Type: Non-Urgent Crossing Status: Found UCIP Comments: No pump. Appears abandoned. Large hole under pipe on WS slope from animal activity. FIELD_STRUCT_DESC: 1 of 2: 18-inch polyvinyl chloride (PVC) irrigation pipe through the levee, 2.5 feet below the crown. Pump on pile structure in the stream. Walkway to the pump. [Additional Reference(s): DWR Levee Log, 2005. USACE San Joaquin O&M Manual 9, April 1964, (HLM 1.49)]. FS Date: 5/21/2013

Pumping plant on metal pier on WS toe.

Large hole under pipe on WS slope.

Pumping plant on metal pier on WS toe. Pipe visible on right under walkway.

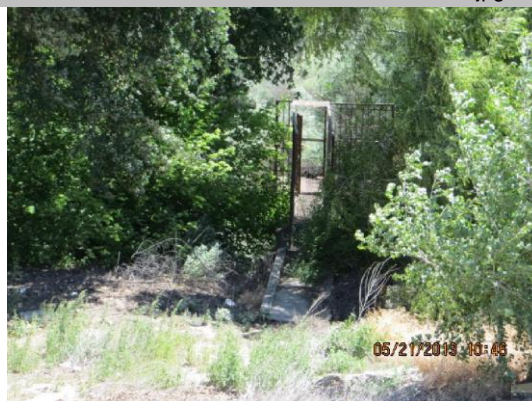
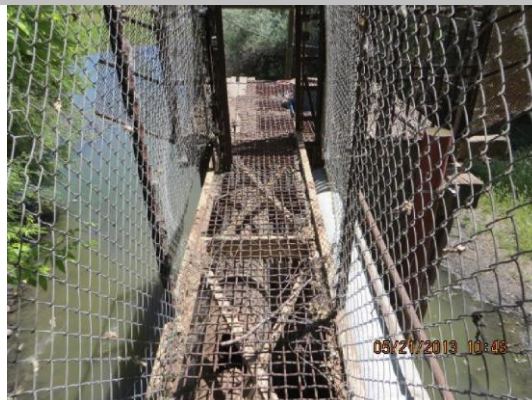
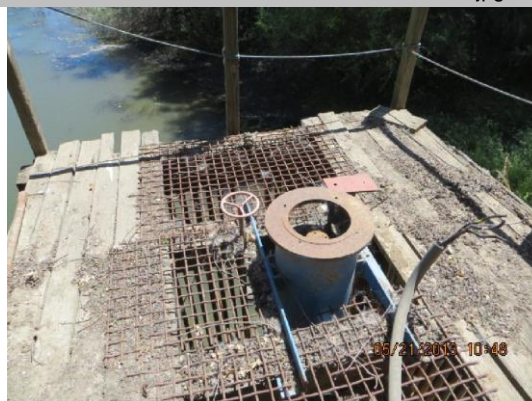
LM Start	1.47	Rating **	M	Issue No.	30	
LM End	1.47	Issue Type +	En	Location *		
Category	Supplemental			GPS Latitude/Longitude		
				Start	End	
Item	DWR UCIP Field Study			37.771735 °	37.771735 °	
				-121.304847 °	-121.304847 °	
DWR ID	23106					
Comment Code						
Inspector Comment						
FS_ID:15179 DS_ID:23106 EP_NO: N/A Repair Type: Non-Urgent Crossing Status: Found UCIP Comments: Pipe open on WS toe at the pump on pier. Pipe abandoned and should be done so properly. FIELD_STRUCT_DESC: 16-inch steel irrigation pipe through the levee, 2.5 feet below the crown. Pump on pile structure in the stream. Walkway to the pump. FS Date: 5/21/2013

Metal pier on WS slope.

Pipe visible under metal walkway on WS slope.

Pipe open at pump on platform on WS.

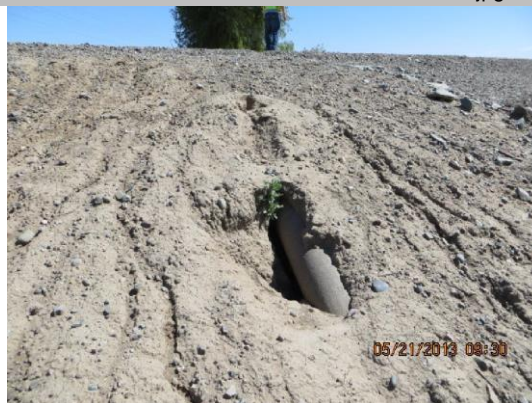
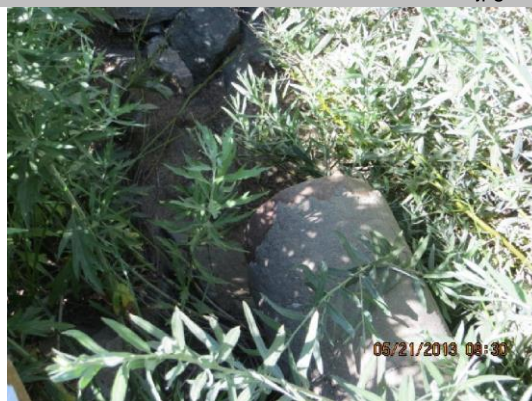
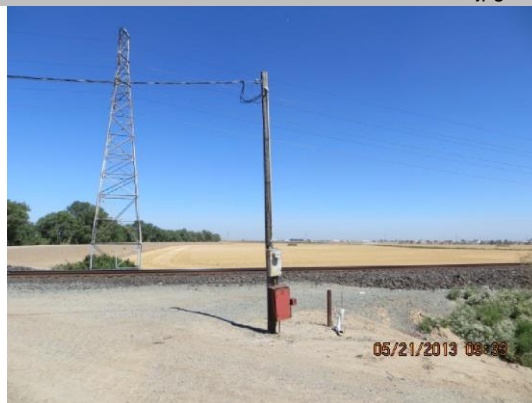
LM Start	0.54	Rating **	M	Issue No.	6	
LM End	0.54	Issue Type +	En	Location *		
Category	Supplemental			GPS Latitude/Longitude		
				Start		End
Item	DWR UCIP Field Study			37.764832 °		37.764832 °
				-121.317405 °		-121.317405 °
DWR ID	19058					
Comment Code						
Inspector Comment						
FS_ID:13636 DS_ID:19058 EP_NO: 13161 Repair Type: Non-Urgent Crossing Status: Found UCIP Comments: Some erosion along pipe alignment on WS slope. FIELD_STRUCT_DESC: 10-inch steel drainage pipe through the levee, 5 feet below the crown. Pump located on a 36-inch concrete standpipe at the landside (LS) toe. A polyvinyl chloride (PVC) pipe runs parallel to the waterside (WS) toe to the train tracks. Air relief valve on the WS shoulder. (Permit No. 13161, 1981 - [owner not indicated in permit database]). [Additional Reference(s): DWR Levee Log, 2005]. FS Date: 5/21/2013

Erosion along pipe alignment on WS slope.

Pipe at outlet.

JP and meter on LS shoulder.

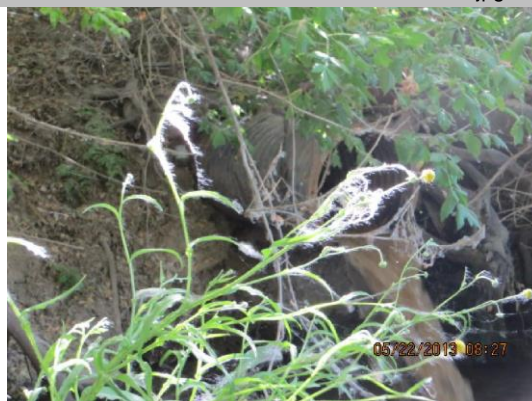
Photo 1 of 3 : UCIP_FA_2018_53388_22441.jpg

Comment Code					
Inspector Comment					
FS_ID:53388 DS_ID:19056 EP_NO: 2966 Repair Type: Urgent Crossing Status: Found UCIP Comments: 10/10/2018 A temporary flexible pvc pipe installed at this location. Although the levee looks to be in good condition, keeping Urgent due to the temporary nature of this pipe and the need for follow up due to potential levee threat (D. Sanoski - DWR UCIP).11/29/2017 Received update from DWR levee inspector M. Khashchuk and pipe is visible on WS toe with flap gate open: back filled during high winter flow to prevent erosion (no photos are available of back fill work). No updates were provided regarding repairs to the sink hole located on LS toe or internal inspection of pipe through the levee, pipe crossing remains urgent. (DWR UCIP - O. Magana)11/16/2016 Visible hole through pipe visible on WS end. Sink hole present at the LS ditch. Evidence of pipe repair visible on LS (see photos) however, no permit was found to document the work. Need to contact owner to determine permit authorizing work. Due to the hole in the pipe recommend internal inspection of the pipe through the levee to determine pipe integrity. (O. Magana - DWR UCIP)05/22/2013 Headwall around pipe at LS toe is failing and should be shored up. Flap gate propped open and should be returned to normal function. (W. Wylie - DWR UCIP) FIELD_STRUCT_DESC: 24-inch steel drainage pipe through the levee, 14 feet below the crown. Flap gate on the waterside (WS) end of the pipe. Two standard reinforced concrete cutoff walls around the pipe in line with the levee shoulders. (Permit No. 2966, 1958 - Dell'Oso Brothers). FS Date: 10/10/2018 2:37:00 PM

Pipe visible on WS toe with Flap gate open.

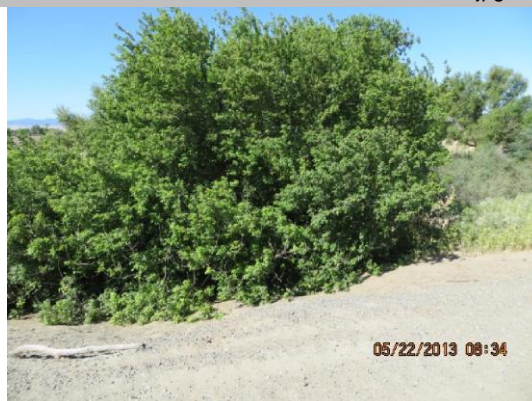
Photo 2 of 3 : UCIP_FA_2018_53388_22440.jpg

Pipes visible under foliage on WS toe.

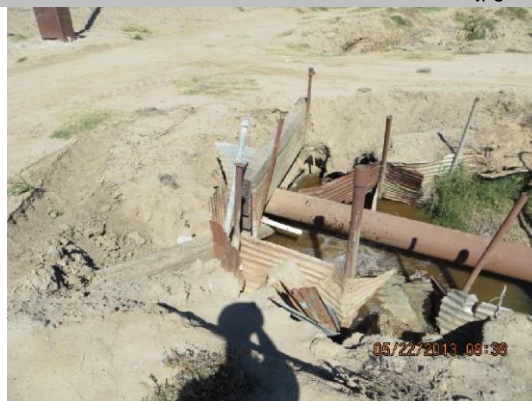
Photo 3 of 3 : UCIP_FA_2018_53388_22439.jpg

Headwall failing at drainage ditch on LS toe.
